Manhole Inspection Summary

Manhole # S33KK_038MH

Insp Date: **3/26/07 12:28 PM**

Location Address: **128 NORTH AVE**

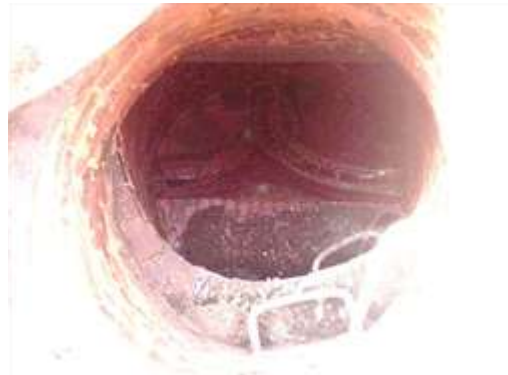
Top View

☐ Parged ☒ **Debris** (not Condition related)

Evidence of surcharge - Bench debris.

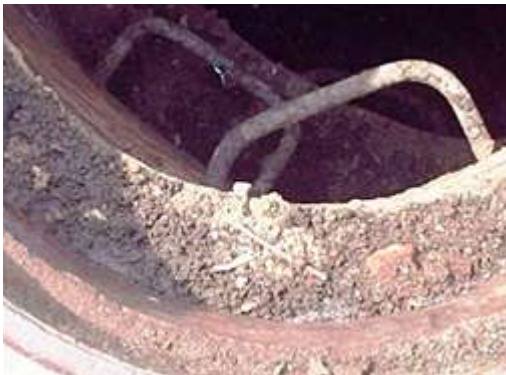
Defect

Offset: **4** (in.)

Infiltration: ☐ None ☒ **Joint** ☐ Cracks ☐ Mortar ☐ Roots ☐ Wall

Frame offset. Adjustment infiltration.

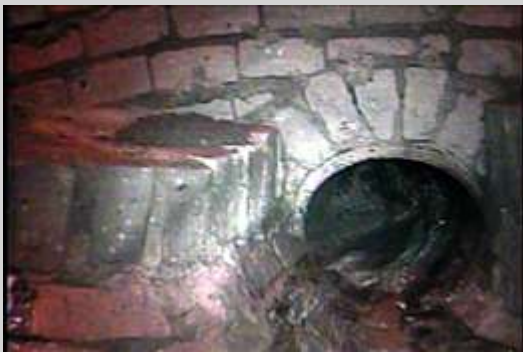
8 in. Circular Gravity Sewer Pipe Out @ 12 O'Clock

Condition: ☐ Sound ☐ Cracked ☐ Root Intrusion ☒ **Deteriorated** ☐ Leaks ☐ Debris

Channel deterioration.

Infiltration: **Evidence** Pipe Seal Cond: **Unknown**

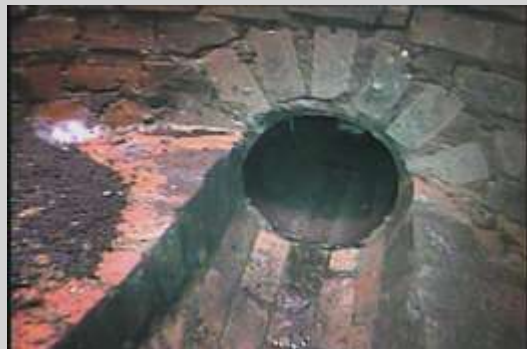
Pipe In @ 9 O'Clock

Condition: ☐ Sound ☐ Cracked ☐ Root Intrusion ☐ Loose Brick ☒ **Deteriorated**

Infiltration: ☐ None ☐ Joint ☐ Cracks ☒ **Mortar** ☐ Roots ☐ Wall

Barrel deterioration and infiltration.

Infiltration: **Evidence**
